KOHNTRON FOREST SERVICES LTD

SAFETY ALERT

May 2018

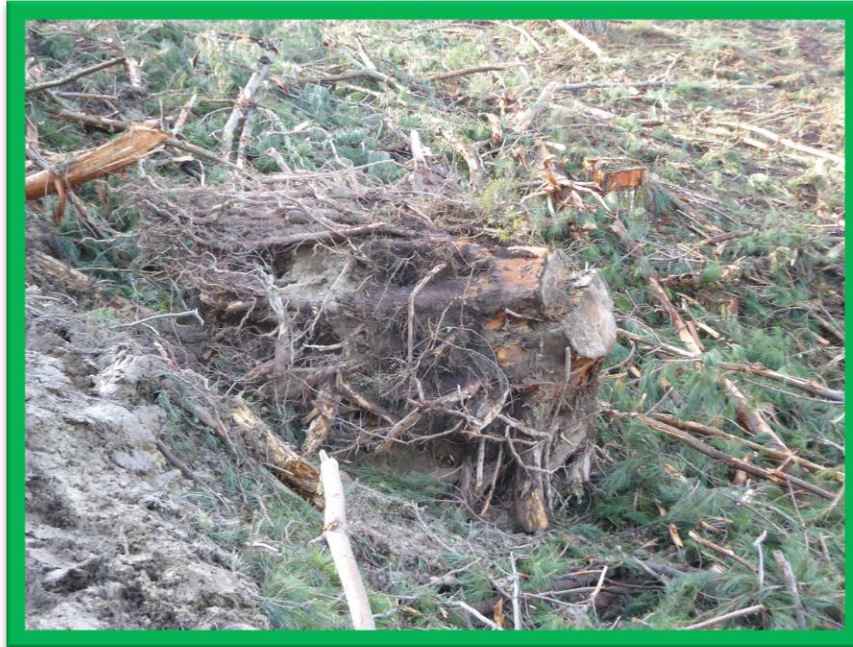
A worker breaking out for a road-line logging operation was almost hit by a tumbling root-ball. The above picture shows a typical root-ball extracted from the ground by an excavator clearing pilot tracks for a road-line logging crew.

The root-ball was extracted and placed in what was thought to be a safe location that would not allow the root-ball to roll down-slope. The near-miss incident coincided with a period of heavy rain.

- Heavy rain dislodged the root-ball.
- The tracking excavator operator misjudged the stability of the slash and soil holding the root-ball in place.

- Thanking the breaker-out for reporting the incident – it has been an opportunity to review the hazard control systems by the three companies involved.
- Reminding all earthworks contractors that extracting material which could later move, such as boulders and root-balls, must be done taking into account:
 - Changing weather conditions.
 - The legal responsibility for all workers to avoid creating a hazard for any other people on site, either in the current operation or in future operations (for example hauler breaker-outs and fallers who could be on site in 1-2 years after the roading is completed).
