# SAFETY ALERT

## Yarder Stabilising Ram Failure Incident

### Thunderbird TY50/70 Towers – Rope Retrieval

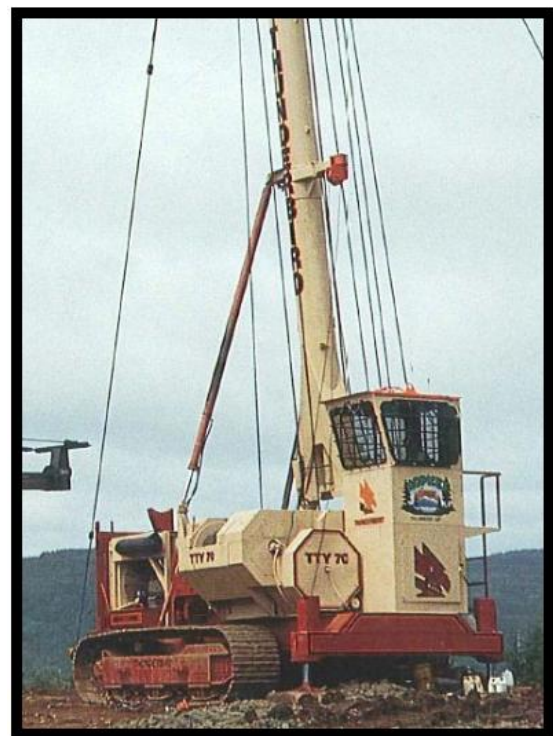
The yarder was being prepared to shift. Running lines and guys had been retrieved. The tower was pushed into vertical position and the stabilising ram locked. The guy ropes were hooked on the chassis and ratcheted up to remove excessive slack. However, during the rope retrieval the tail rope over-spoiled or “birdnested”. A plan was then made to untangle the rope and run the tail rope out so it could be correctly fleeted back onto the drum. A grapple operator was positioned in front of the hauler to pull the rope out and then manage rope tension as it was wound back on. Another worker was deployed to sit beside the drum and assist fleeting the bottom layer and a 3rd worker, the

hauler driver, had the tail drum engaged, and idling dead slow in 1<sup>st</sup> gear. The yarder driver was observing the drum and stabilising ram through the cab side window. The rope was being wound slowly onto the drum, and the first layer was half completed when without warning the spear on the stabilising ram snapped. The broken spear shot forward and landed on the workers hand who had been positioned near the drum. The injury was severe requiring four fingers to be amputated

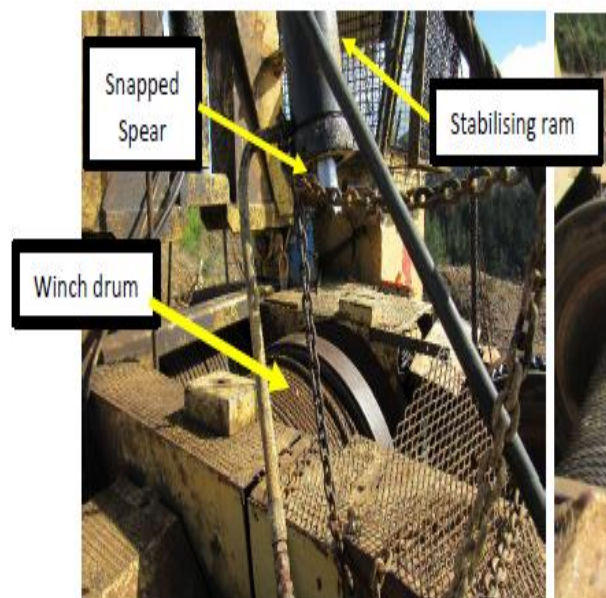
- The investigation revealed that the incident was the result of a stabilising ram failure.
- It identified that the Thunderbird manual prescribes the slackening of all guylines before rope recovery, therefore the tower was not supported by guylines when the stabilising ram failed.
- Also, the stabilising ram spear had been replaced with induction-hardened steel rather than the original mild steel design. Induction hardened steel provides excellent wear resistance and strength but does not have the same ductile microstructure of mild steel, which allows it to deform (bend or stretch) significantly under stress before fracturing, it absorbs energy well.

Figure 2. Close up of the hauler showing snapped spear

- 1. GUYLINE SAFETY:** While Thunderbird manuals allow slackening all guylines and locking the pole before rope recovery, it is recommended to keep at least one rear guyline in place to prevent tower collapse if the stabiliser ram fails.
- 2. STABILISING RAM SPEAR:** Owners must verify the steel grade of stabiliser ram spears. It is recommended that a replacement spear should be consistent with the original mild steel composition with good energy absorbing ductile properties.
- 3. LAGGED DRUMS:** Rope fleeing exposes workers for 15–20 minutes. Lagging drums reduces this risk. Owners should consider replacing at least the front drum when machines undergo major servicing.
- 4. ANNUAL INSPECTIONS:** Towers must be inspected annually by CBIP-certified inspectors. Inspectors should be briefed on the Kohurau incident and the importance of spear verification and ram integrity.
