HAZARD ALERT

BRANCH ENTERS HARVESTER CAB

July 2018

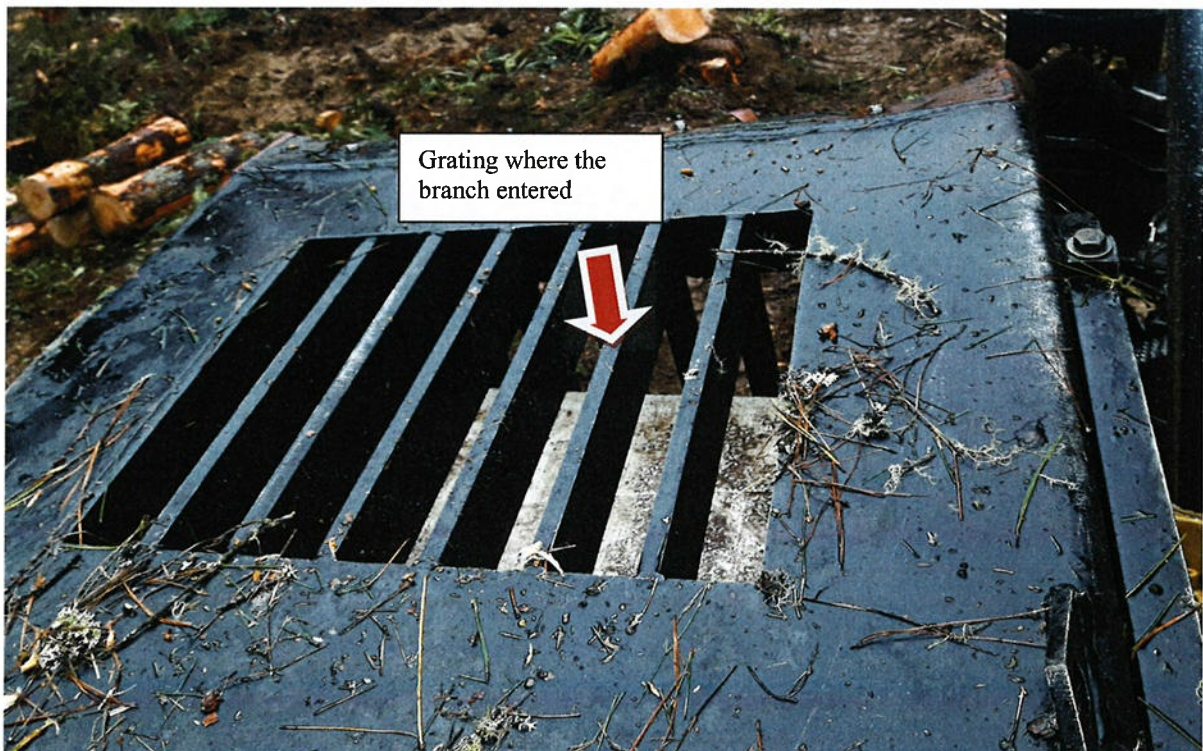
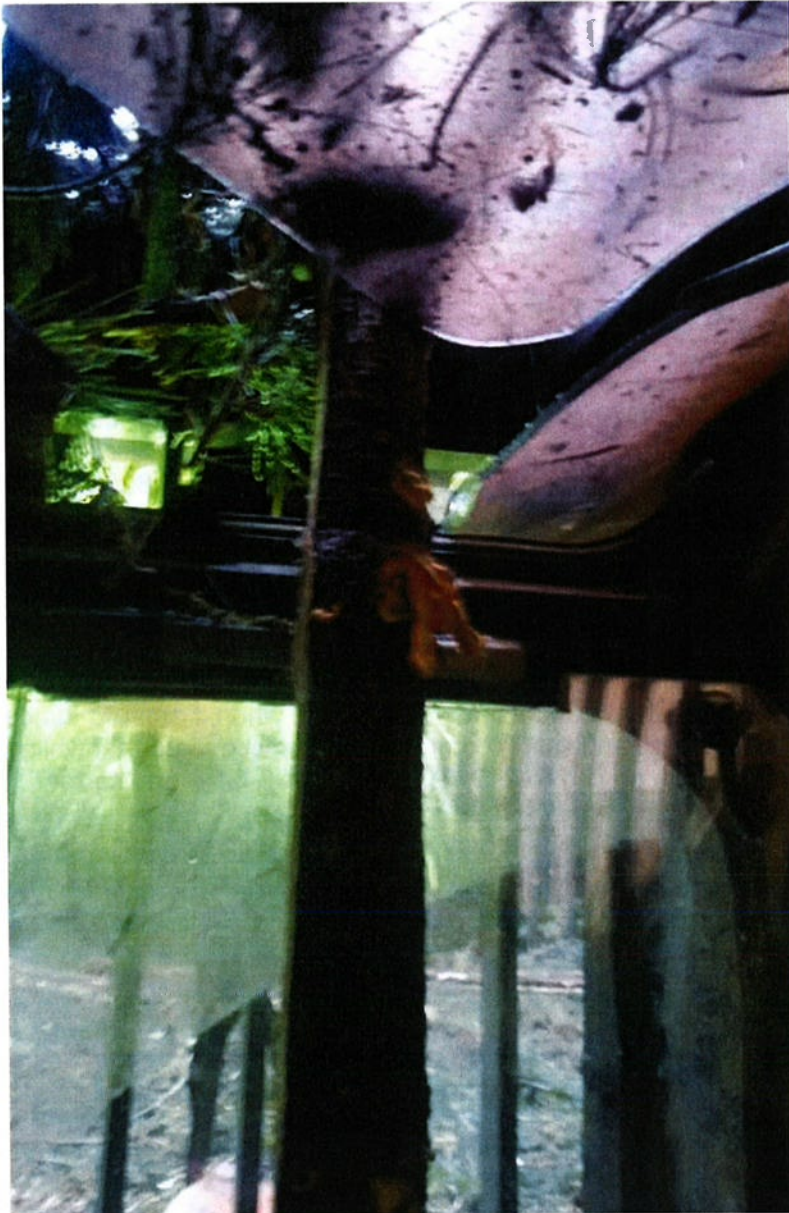
A Cat 330C harvester was felling trees when a heavy tree branch came through the machines roof grating hitting the operator's right leg after cutting through his Schoen gumboot. The injury sustained was luckily only bruising.

Below the grating there was a standard sunroof/cab hatch with a (7mm) polycarbonate window, this afforded very little resistance as the branch smashed through when it entered the cab.

After discussion with the engineering certification company it was discovered that while the machine was certified and tagged as having ROPS, COPS, FOPS & OPS and current, it did not have OPS over the grill on the roof.

- The protective structure didn't provide adequate protection from vertically falling branches of said diameter.

- Contractors/ principals should consider specification of OPS protection on harvester roof grills.
