Mechanical Failure on Hauler Spar

Investigation undertaken and Report Prepared by Brady Clements on behalf of Robbins Contracting Ltd

Incident Details

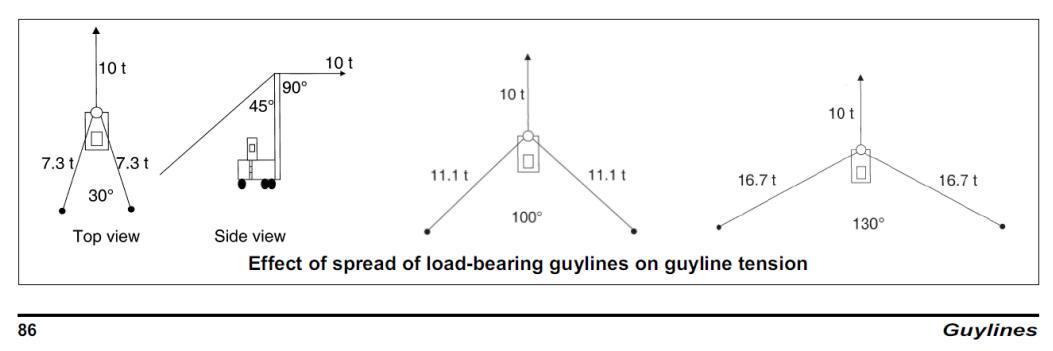
Hauler Information: The hauler was a Madil 071 tower hauler which has three guy rope drums and three working drums. The tower certification was in date on the tower and the cab had been re-certified in July 2019. The hauler operator had undertaken the required daily checks for the hauler and the guy line angles where the guy lines are attached to the dead men were documented. These angles were under 45° which is the angle industry recommends having guy line angles at. (Image 1)

The hauler had been set up within the required specification the guy lines were spread evenly and the angle of the guy lines when attached to the dead men were all under the required maximum of 45°.

Image 1: This image is taken from the *Cable Logging Best Practice Guide for Forest Harvesting* it states that the recommended angle where the guy line attaches to the dead man is recommended to be less than 45°

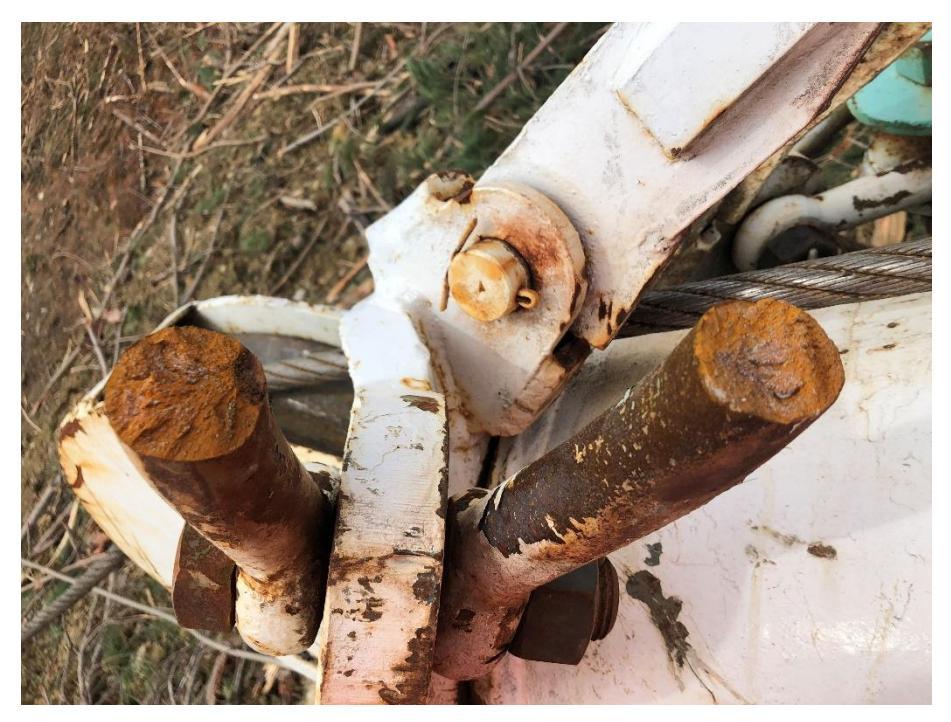
Description of the Incident: When the shock load occurred, it triggered a mechanical failure on an integral component on the hauler. One of the D-shackles that attached the guy line block to the top of the tower failed. This particular shackle has cracked and was compromised, breaking on one side, which resulted in the shackle stretching out of shape and rupturing completely (refer to images 2,3). The failure of the D section of the D-shackle has resulted in the guy line block releasing from the top of the tower and dropping towards the ground, causing the left-hand guy line to go slack. The guy line block did not fall all the way to the ground as the safety strop that was attached to the top of the spar through the guy line blocks worked and caught the block. Slack from the guy line, however dropped 8 meters and landed on the ground beside the hauler.

The main cause of this incident was a mechanical failure of one of the d-shackles that attach the guy line blocks to the top of the spar. This failure happened as a result of the shock load that occurred when the drag was being extracted to the landing by the hauler. As outlined earlier in this report the hauler had a current tower inspection certification.

It is unclear what has caused the shackle to fail on the hauler spar, on inspection there is a very small crack on the shackle where it is rusty. Given the age of this hauler it is estimated that the hauler is around 40 years old the steel shackles could have been weakened over time. When talking to Darren Hall about the age of the shackles that hold the guy line blocks on the hauler spar, he stated that he thought these shackles could well be the original shackles. Darren stated that the shackles were however still in specification. When the hauler spar was brought out to the Hauler Engineering workshop and the dismantling process was underway in order to strip the required items off the spar to start the rebuilding of the spar. The two remaining guy line block shackles had to be gas cut off the hauler in order to get them off the spar, Darren stated that this indicated the shackles were very old.

Image 2: Shows the two ends of the shackle that the D section has broken out of, the pin and two sections are still attached to the hauler spar.

Every seven years the guy lines are required to be replaced on tower haulers, however there is no mention of the replacement of the shackles that attach the guy line blocks to the hauler spar. On old machines such as the Madil 071 of Robbins Contracting the shackles that hold the guy line blocks on the spar could be very old. Darren Hall stated that every seven years when the guy lines are replaced, the guy line block shackles should be replaced as well.

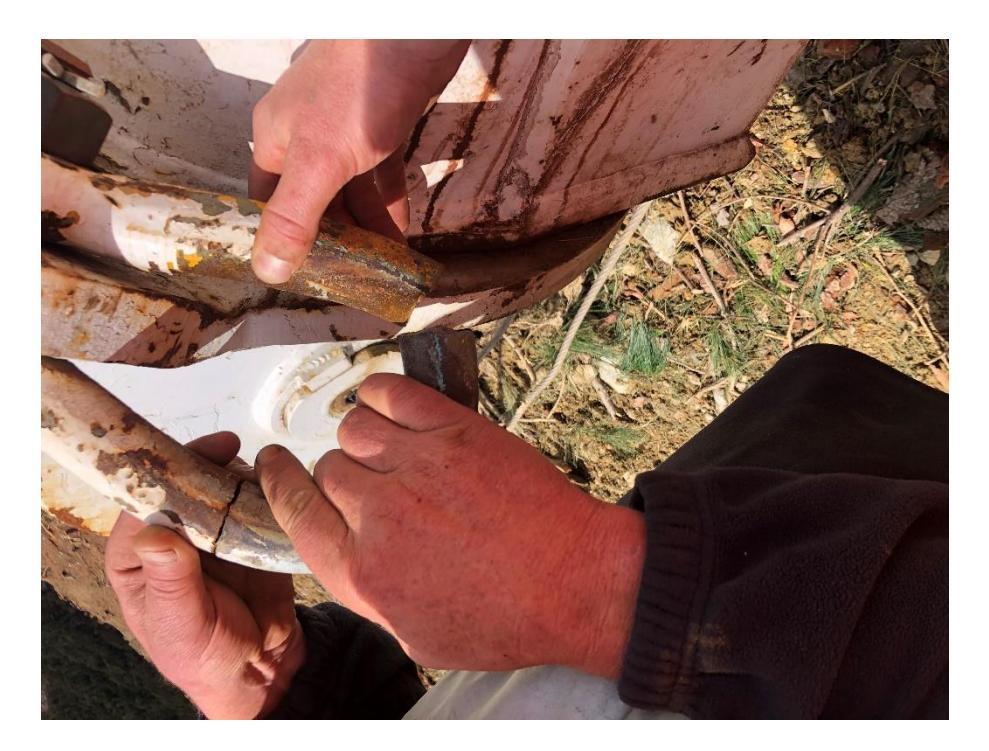
Image 3: Shows the broken section of the shackle pieced together this indicates the stretch in the shackle when it broke. This image indicates one end of the shackle has broken and stretched the D section of the shackle out of shape, which has then caused the other end of the D section to break.

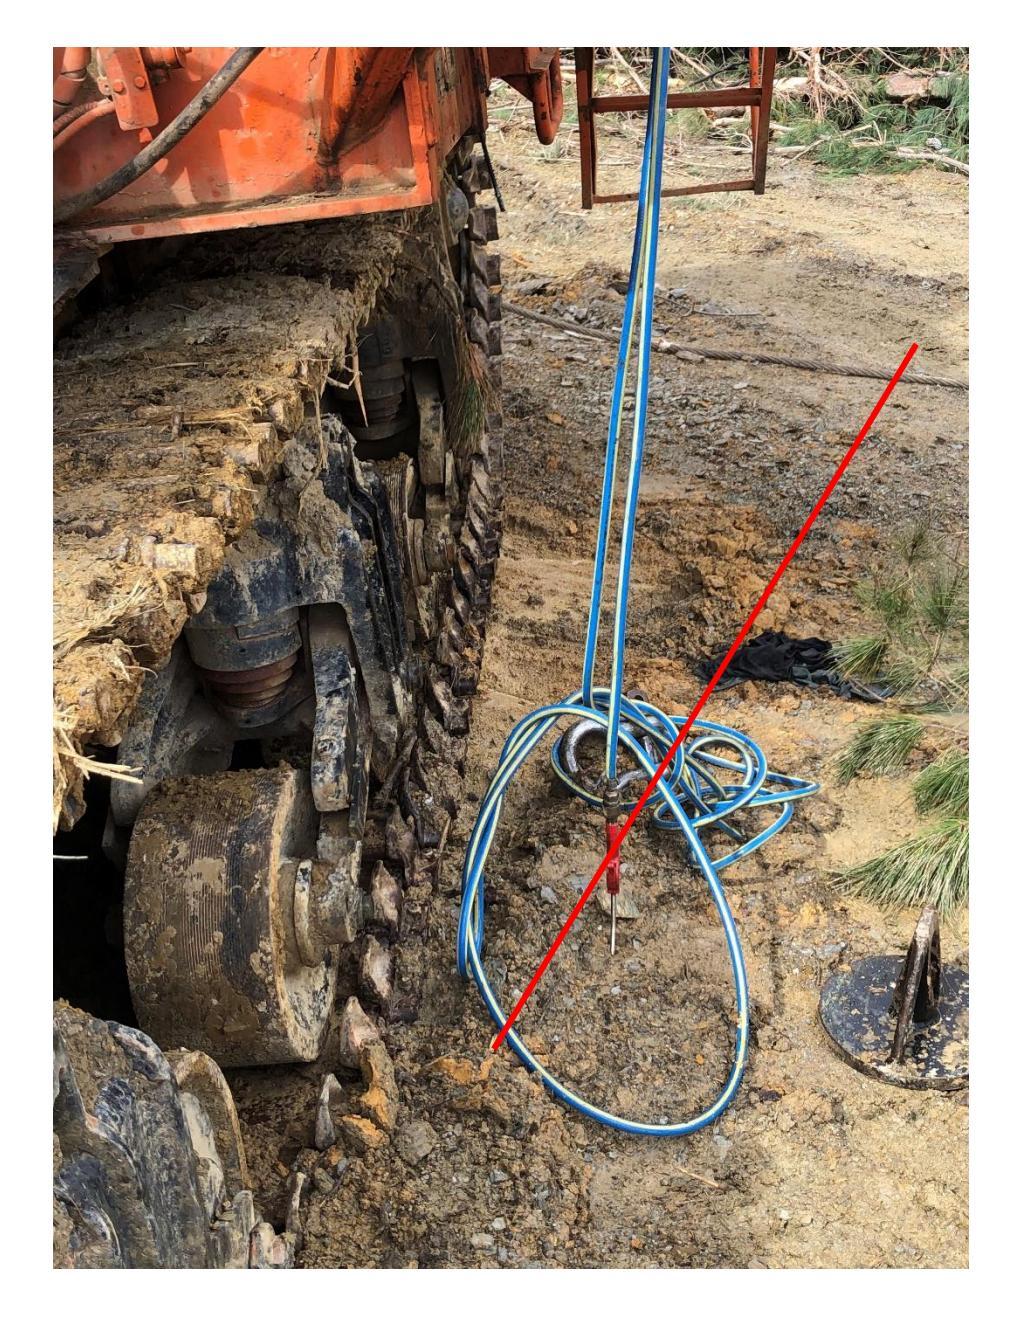
The failure of the left-hand guy line resulted in the weight supported by this guy line transferring to the two remaining guy lines on the hauler. The two-remaining supporting guy lines: the middle guy line located directly behind the hauler spar and the right-hand guy line located on the cab side of the spar, now supported the entire weight of the hauler. Due to the loss of the left- hand side guy line this weight was now unevenly distributed across the hauler and the remaining two guy lines were inadequate to provide comprehensive restraining support. This caused the hauler to pivot from the centre of the track frame towards the right-hand guy line, the hauler rotated on the ground. (Image 4) Please note:

Image 4: This indicates where the hauler has pivoted when the left-hand guy line has failed. The red line in the image indicates where the hauler has moved to. The hauler has been dragged back into position in order to get the vehicles past post incident.

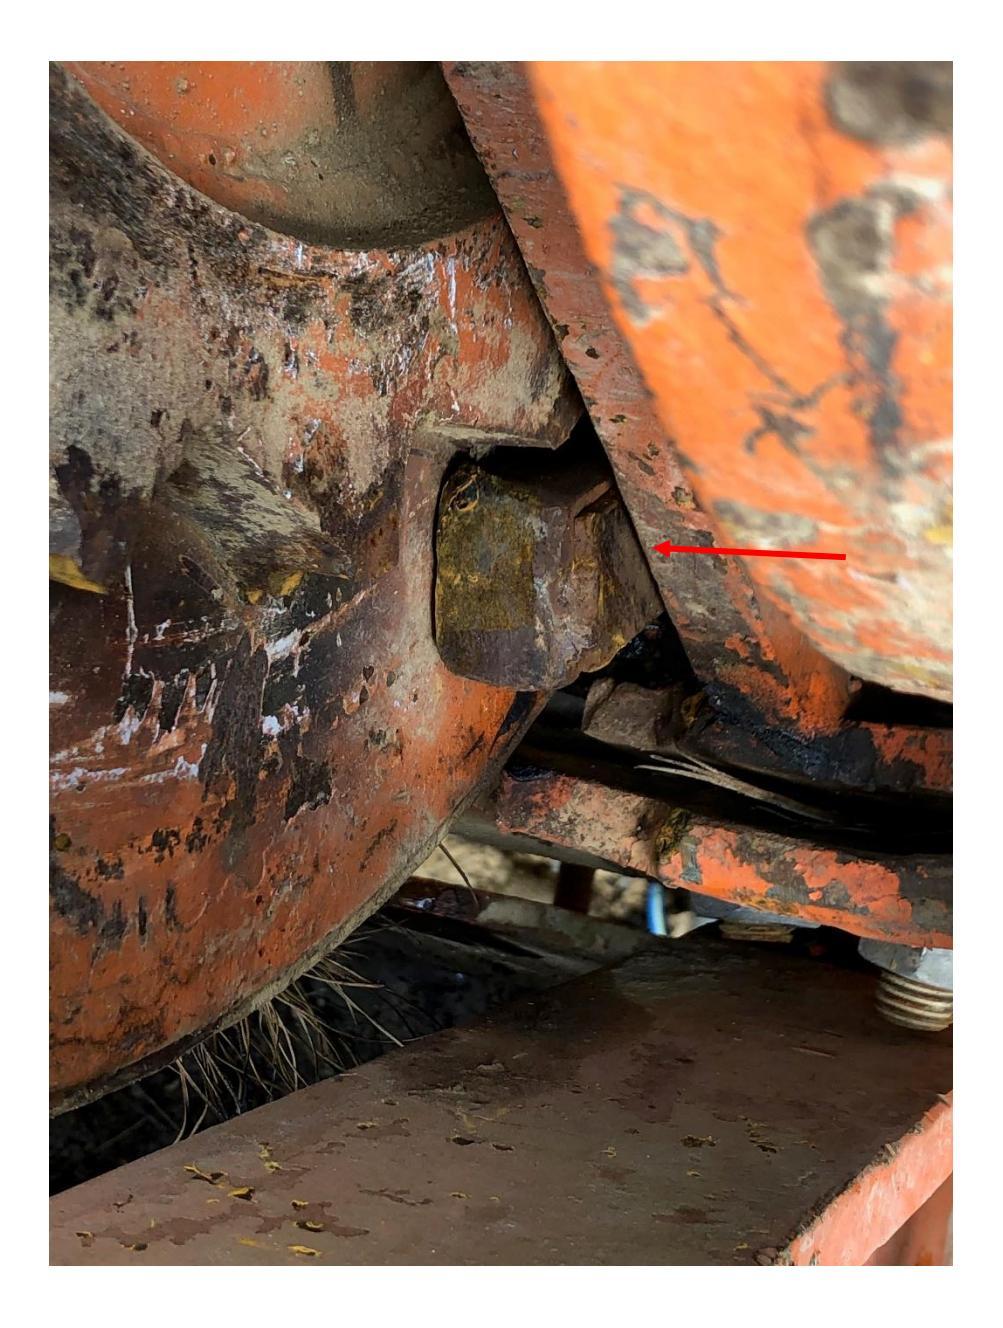
Further Events Following the D-Shackle Failure: When the shock load has occurred combined with the hauler pivoting towards the right-hand guy line the dog spike that slots into the notches on the middle guy line winch set has dropped out slightly. (Image 5) It remains unknown as to why this has occurred, during the investigation engineers whom deal with haulers and tower certifications have been spoken to regarding this and they are unable to shed any light on why the dog spike would have dropped out. The dog spikes are held in place via a spring system and with air pressure. The dog spike has not dropped out completely but has dropped enough to compromise the working capability.

Image 5: This shows the dog that drops into the notches on the guy line drum, this holds the drum in place and prevents the drum unwinding. This is the dog that has dropped out slightly as referred to in the report.

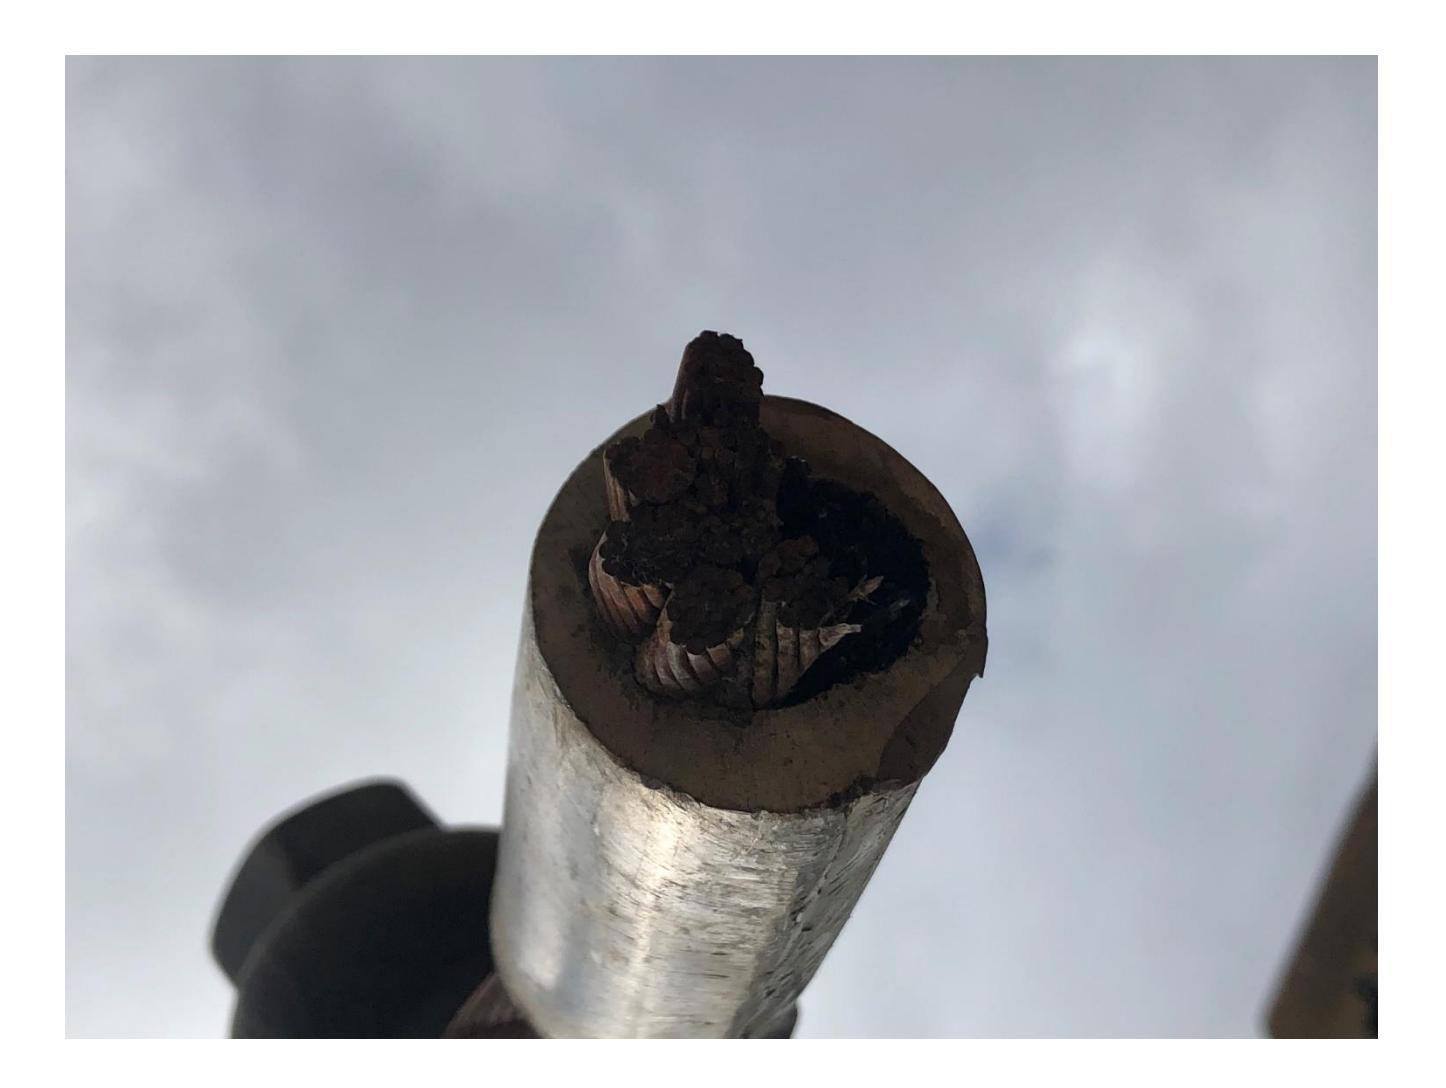
The pendant guy which is a guy line that is attached to the hauler base and attached to the spar, used as a safety device when the hauler is being moved with the spar up. This guy rope prevents the hauler spar falling forward, this guy line is always attached. When the added weight has been applied this guy line has failed. (Image 6) It is unknown as to why this has occurred as the pendant guy line was within specification for rope diameter and breaking strain. Once the pendant guy line had broken the middle guy line drum mechanisms have started to fail. (image 7) The dog spike has slipped out of the first notch and the guy line has started to unwind off the drum. The dog spike has still been held in against the notches but due to the dog spike dropping out slightly and the mechanism being compromised the guy line drum up has failed under the weight the internal gears have been shorn and destroyed. The guy line has continued to unwind allowing the hauler spar to fall forward due to the weight of the skyline across the gully.

Image 6: Shows the end of the pendant guy which has failed in the incident due to the shock load.

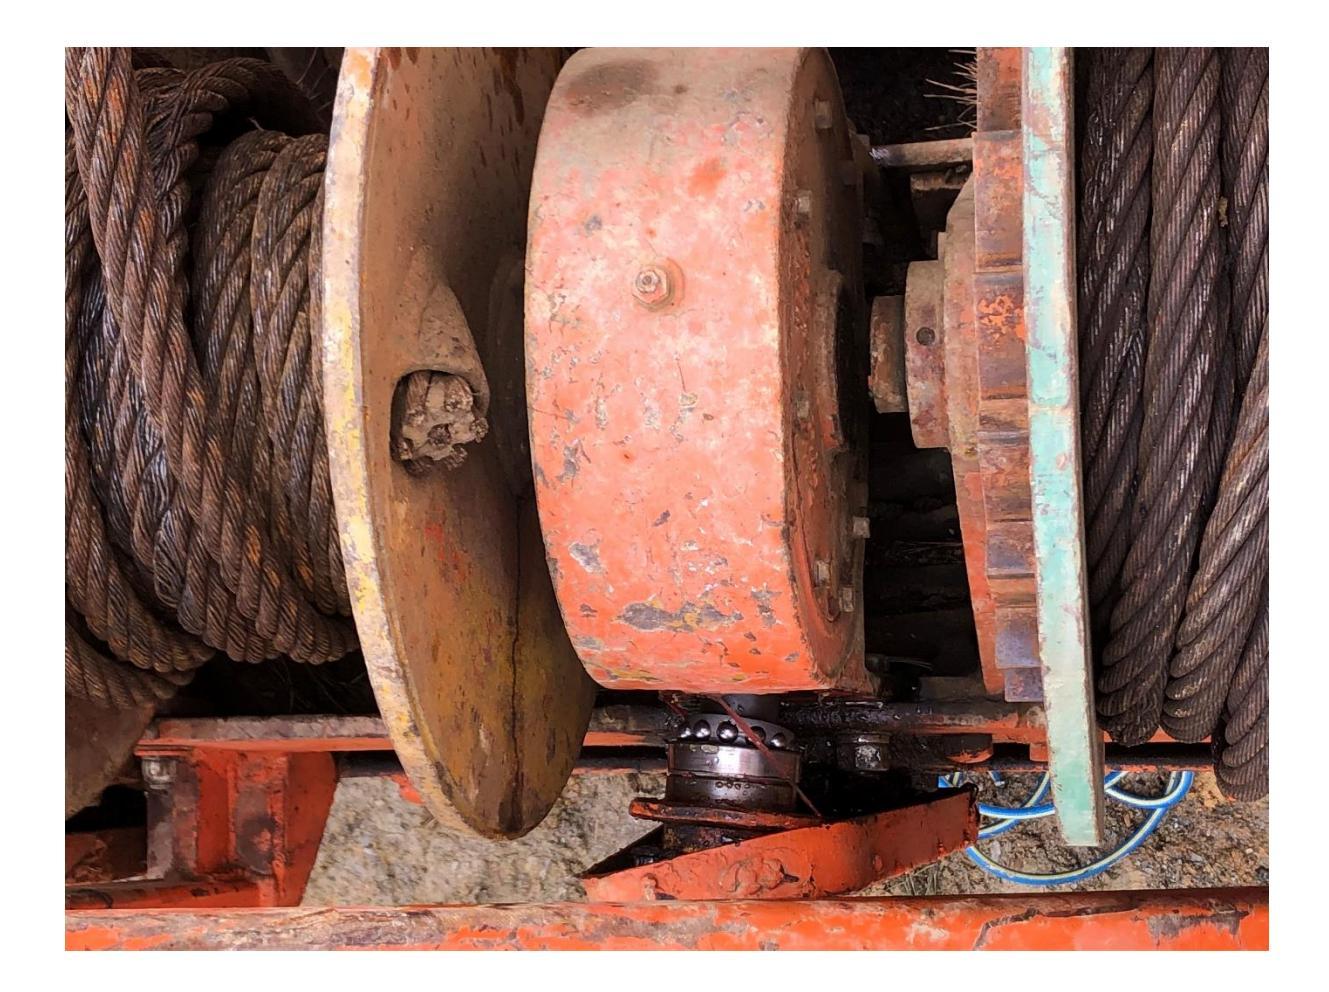
Image 7: shows the internal mechanisims that have failed on the middle guy line drum. The intenal drive motor system has been destroyed and collapsed.

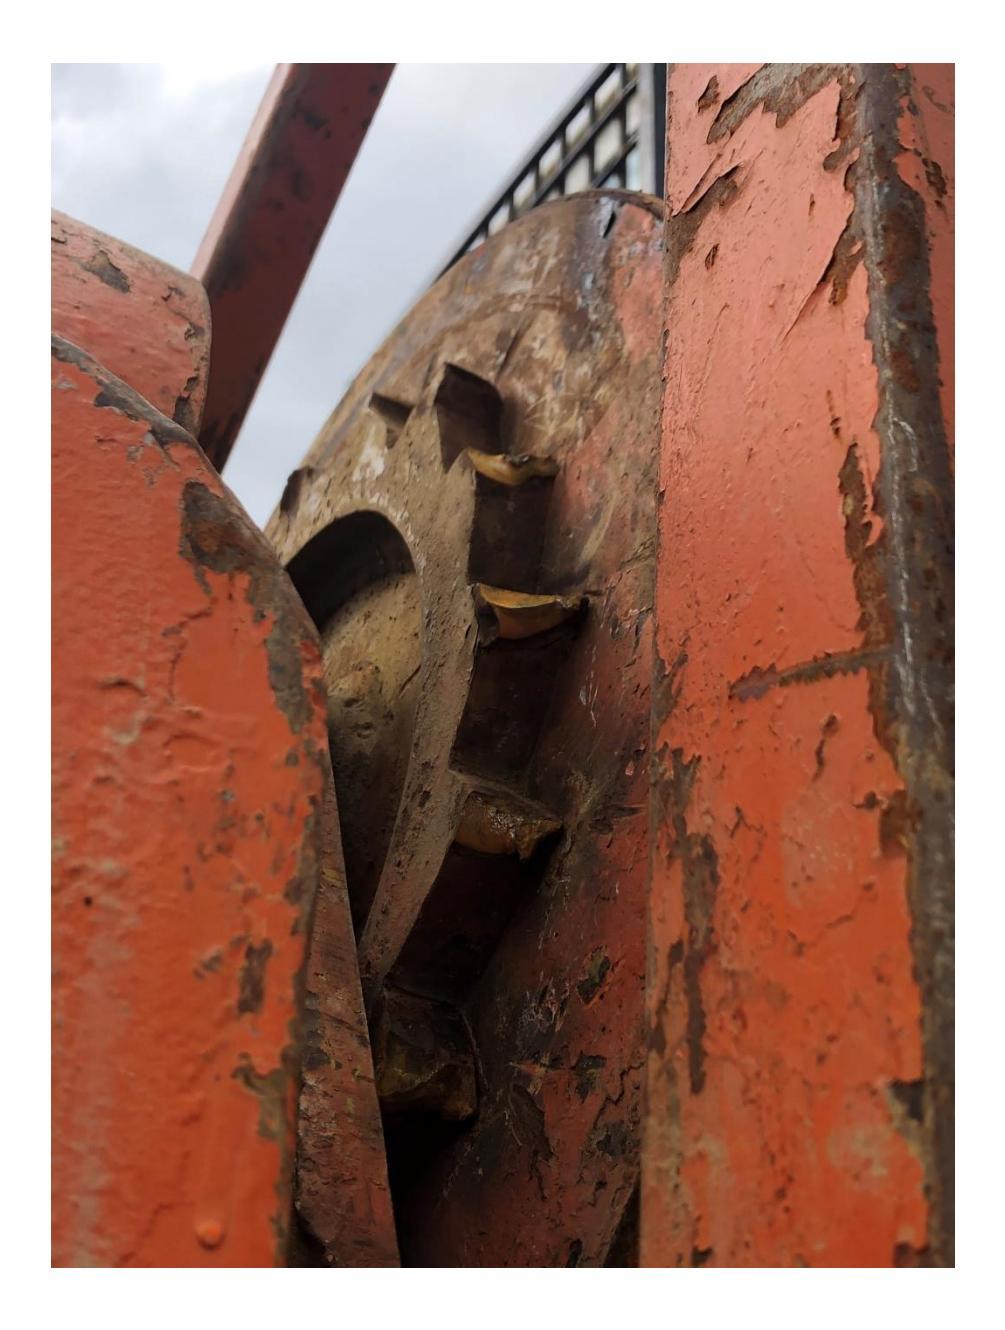
It is important to note the condition of the guy line drum and the notches where the dog spike slots in. This indicates that the dog spike was still in place however for the reason unknown it has dropped out slightly and allowed the drum to unwind. The condition of the notches where they are worn where the dog spike has been making contact indicates that the dog spike still had force behind it holding it in place. If the dog spike had dropped out completely then there would have been very little wear to the notches on the guy line drum. (Images 8,9) It is thought that the weight applied to this middle guy was so great that the mechanical components failed. The tower has continued to fall forward until the second pendant guy which is located on the right and side of the hauler by the cab has pulled tight. This pendant guy has stopped the spar falling right to the ground. (Image 10)

Image 8: Shows the wear on the notches of the guy line drum where the dog has dropped out slightly. Not the wear on the notches as the dog has been held in against the notch but it has still been unwinding.

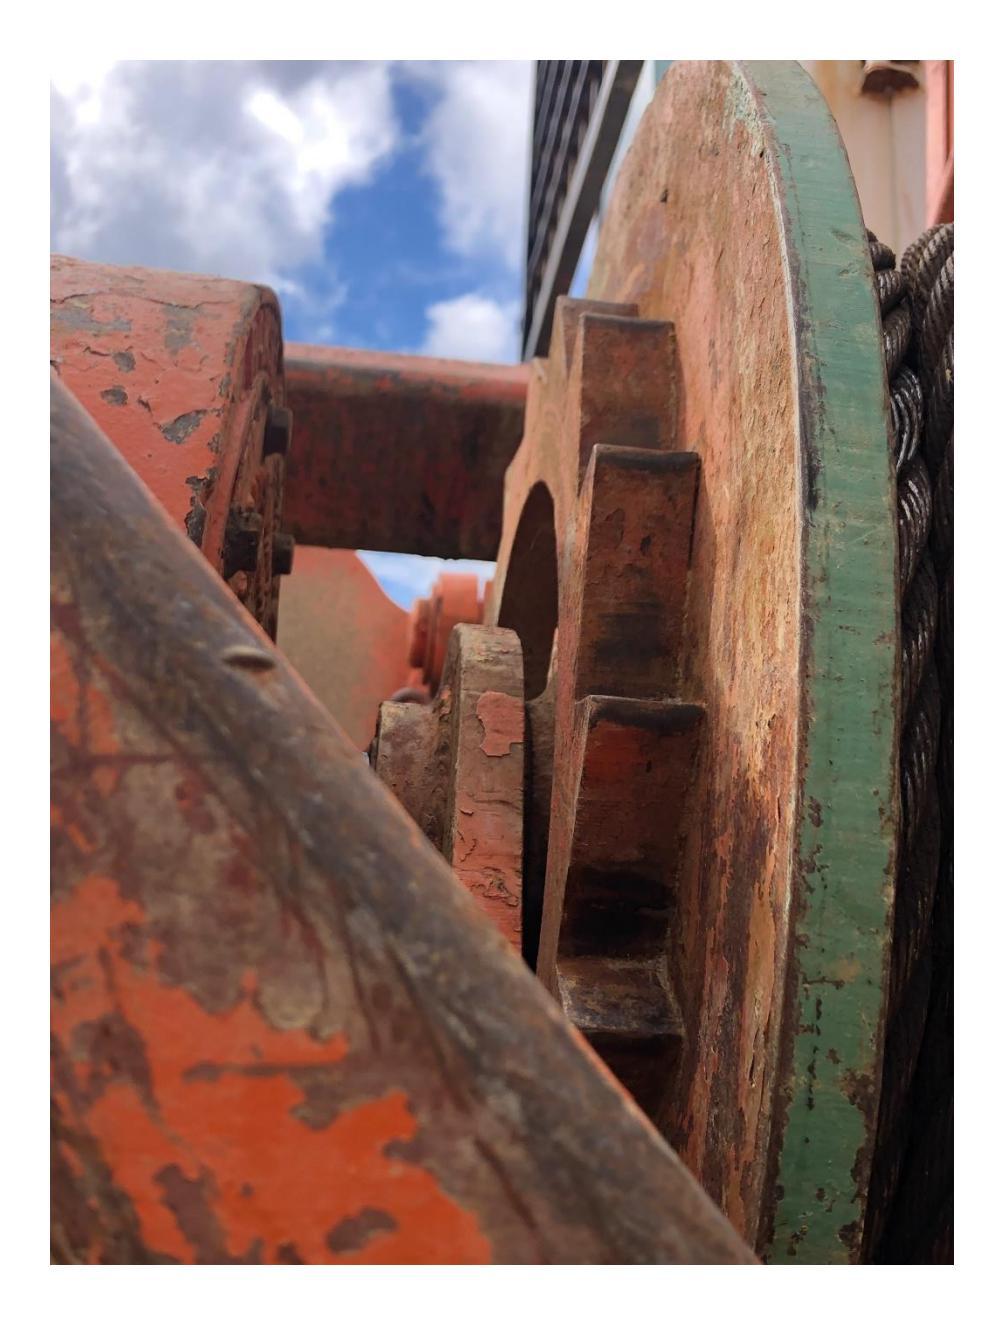
Image 9: Shows a non-worn guy line winch drum, if the dog spike had dropped out completely the drum would have looked like this as there would have been no resistance on the drum from the dog in the notches.

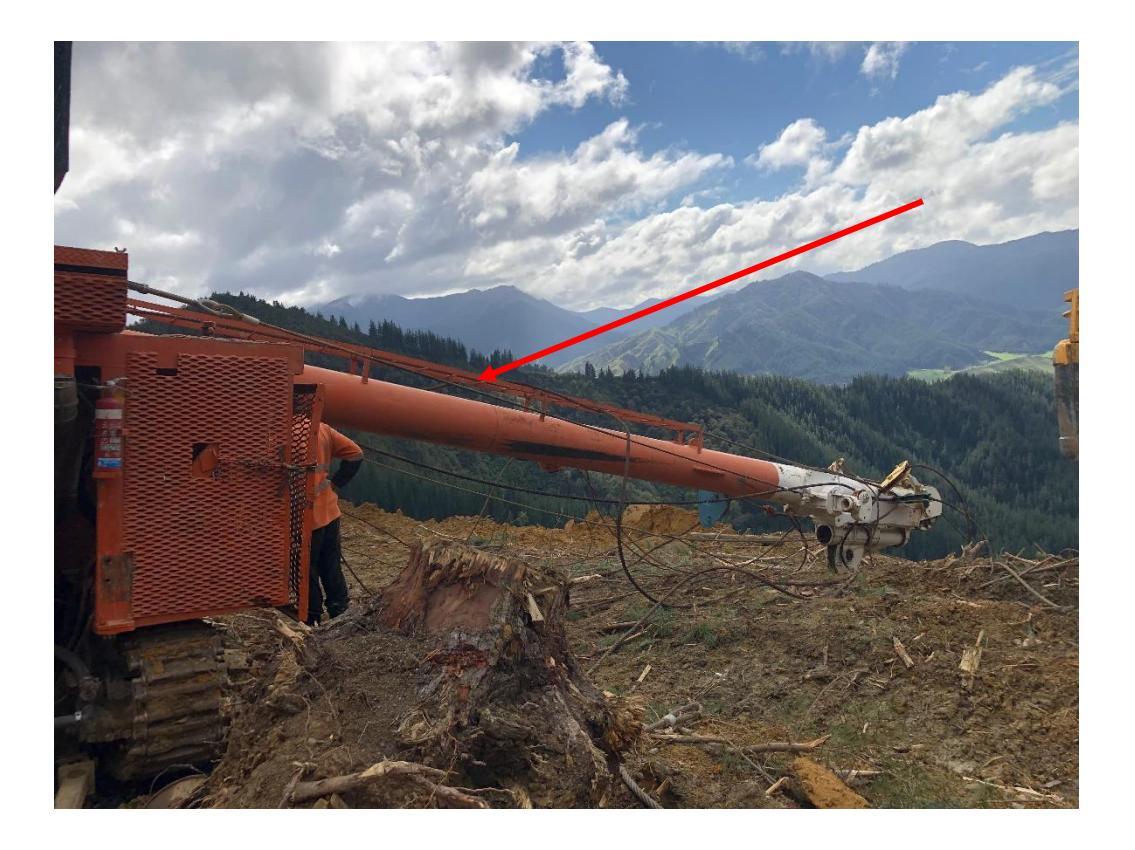
Image 10: shows the pendant guy located on the cab side of the hauler that has pulled up tight and prevented the spar from hitting the ground.

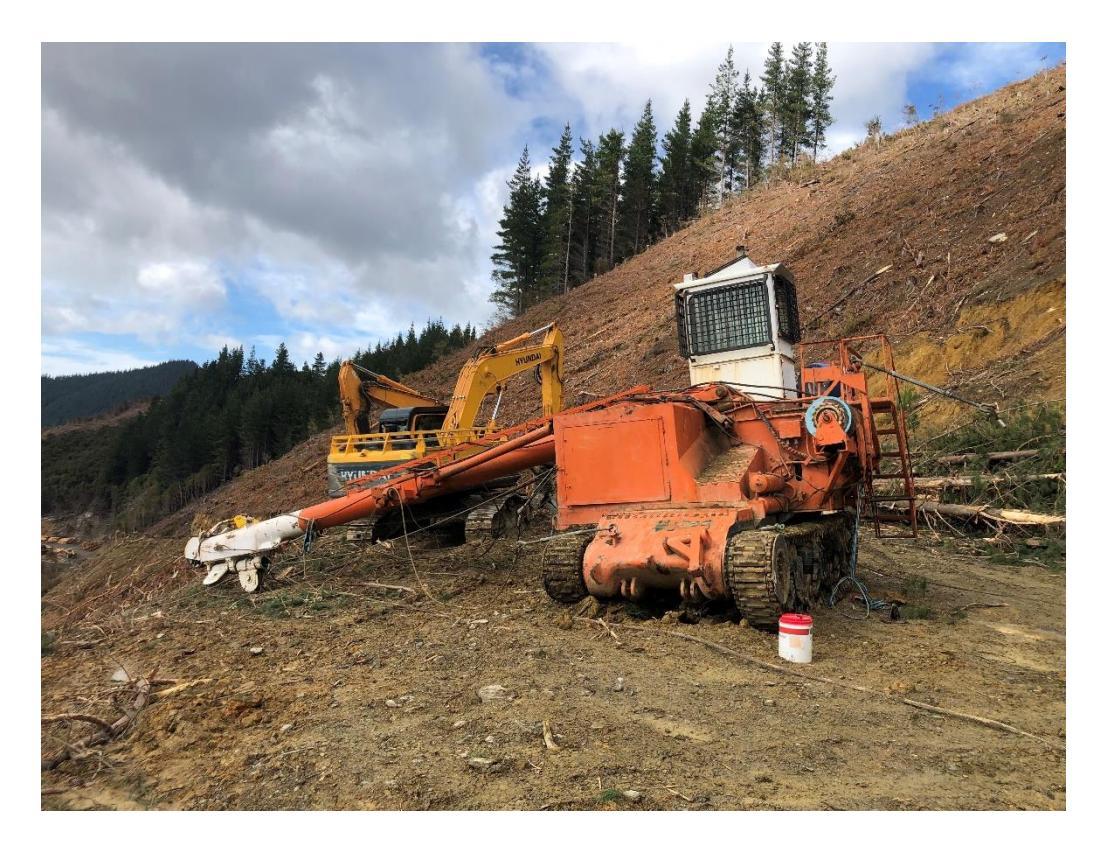
Image 11: Shows where the spar has come to rest out the front of the hauler, note the pendant guy that has pulled tight has prevented the spar hitting the ground

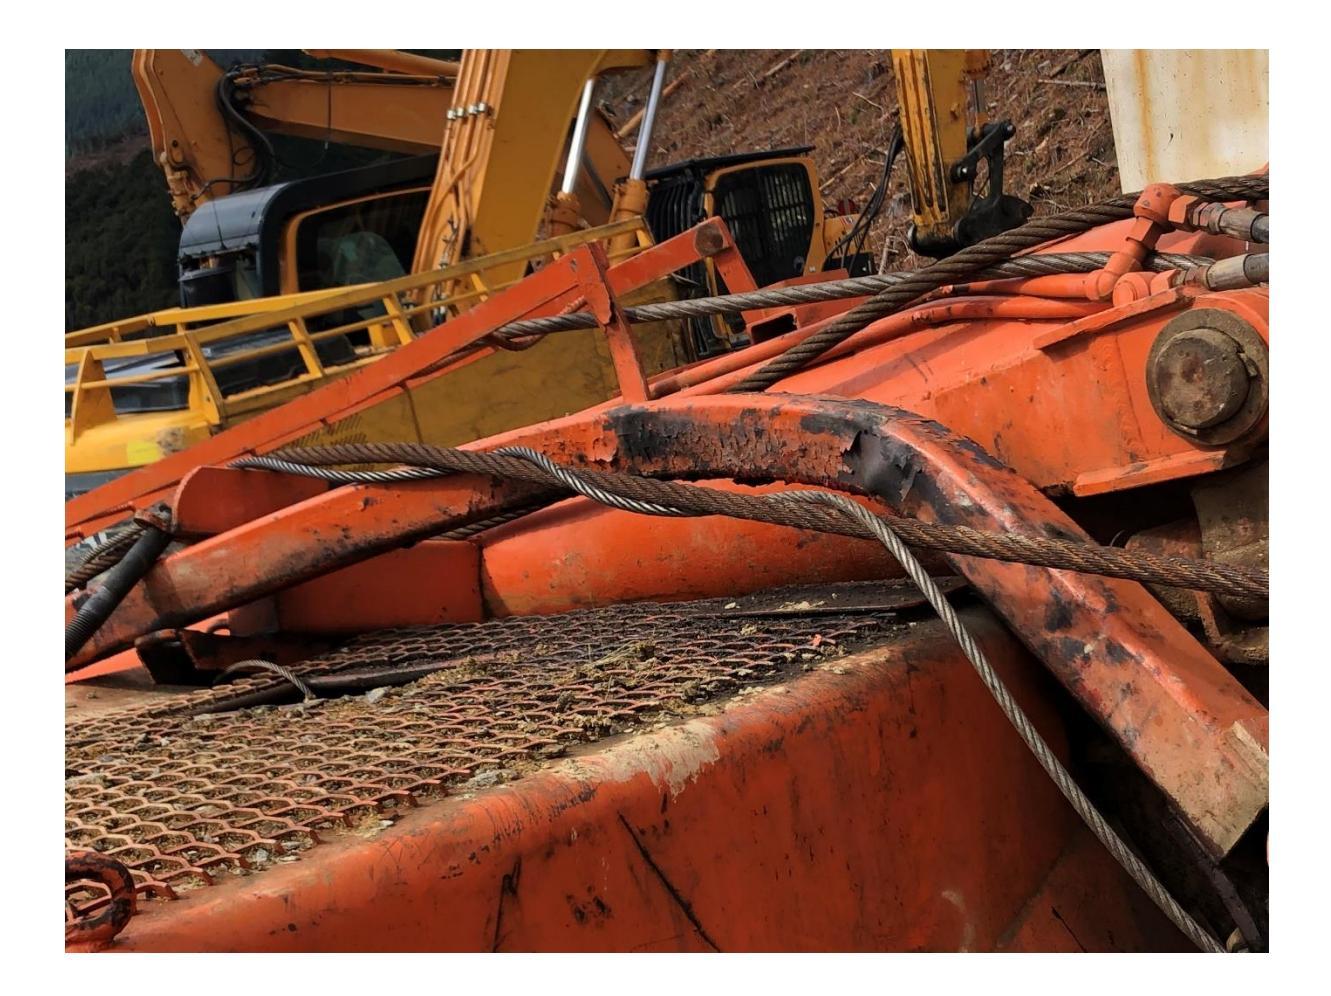
When talking with the hauler operator during the investigation process and retracing the turn of events from in the hauler cab it become very clear that this all happened very fast. The hauler driver recalls feeling the hauler spar lurch forward slightly then hearing a loud bang and the left-hand guy line becoming very loose. The hauler has then pivoted towards the right-hand guy line and the spar has started falling forward. He said the spar didn't fall forward quickly but just gradually fell forward, he said it happened in one motion and he was not able to react by trying to lower the skyline. The hauler spar continued to fall forward until the right-hand side pendant guy pulled up tight and held the spar, the top section of the spar was 1m from the ground with the rope sheathes just off the ground (Image 11) He recalls hearing all manner of noises which sounded like steel bending and flexing as the hauler spar has fallen forward. These noises would have been from the various steel structures bending as the spar has been moving forward. (Image 12)

Image 12: shows the various steel structures on the hauler that have bent while the spar was coming forward on the hauler.
