SAFETY ALERT

Track Guard Came Loose Jamming Track

February 2020

Alert No.001

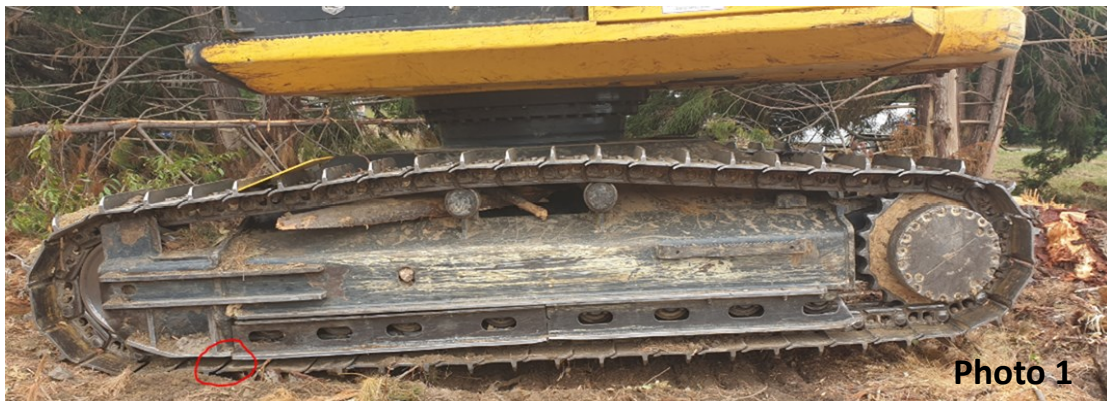
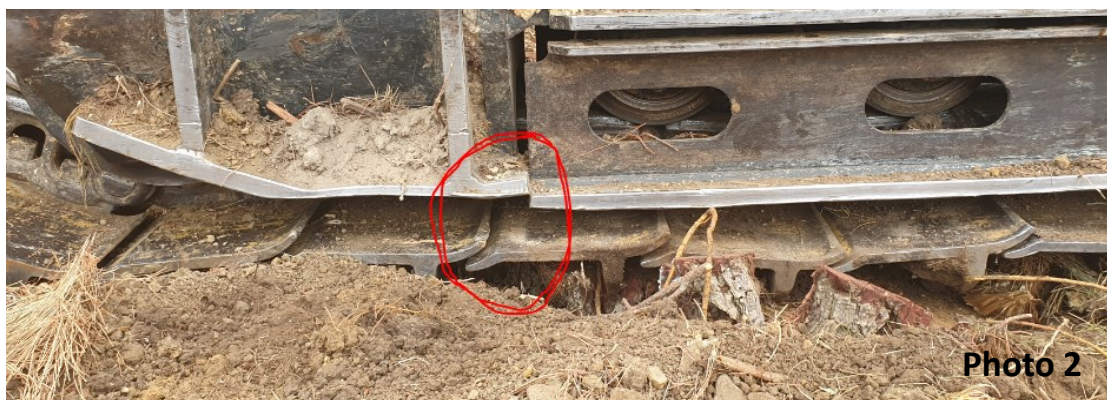
Upon assessing the machines damage it was discovered that the track guard on one side of the machine had come loose and had fallen into the track causing it to lock up.

This had caused the machine to screw suddenly on the hill and roll over. (see photos 1&2)

Contractor Action: Track Guards should be checked on all machines to ensure they are secure.

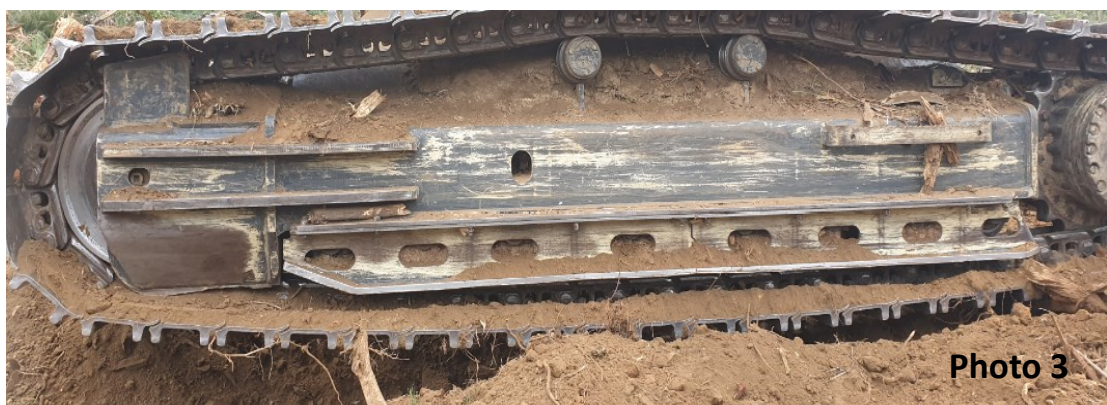
There are different track guard designs. (see photo 3)

Komatsu is talking to the manufacturer of the track guard regarding the design.
