12 August 2020

SAFETY ALERT

Skid-worker narrowly avoids serious injury after falling from the deck of a hauler

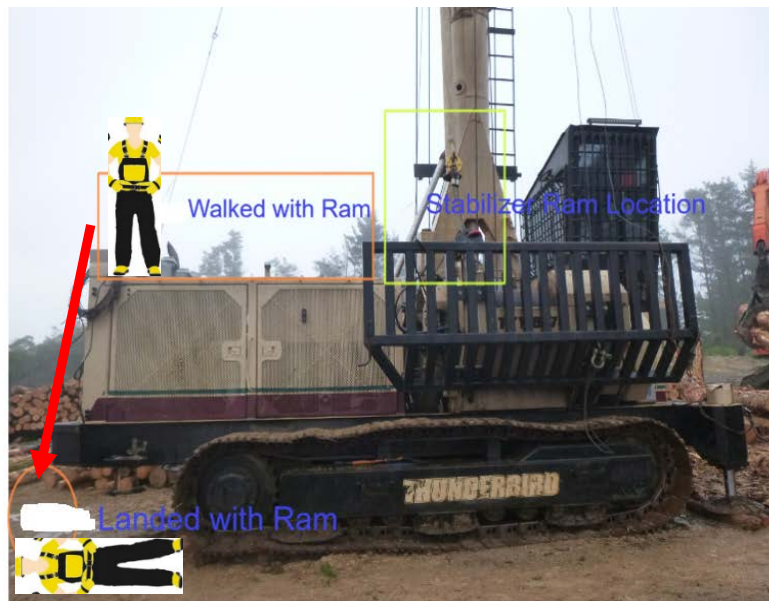
A skid worker in a hauler operation was tasked to help remove a damaged stabilising ram from a hauler. The worker climbed up onto the hauler to assist with the removal of the ram, he was wearing spiked boots at the time.

At the suggestion of a service mechanic, he carried the 40 kg hydraulic cylinder across the top of the engine bay and threw it over the side of the hauler. As he did so, part of the cylinder caught his belt, dragging him off the hauler and falling 2.8 meters. He fortunately only suffered bruising to his pelvis.

Maintenance of harvesting plant and equipment can be hazardous and requires a planned approach. A maintenance plan with a risk assessment should have been undertaken by the crew and mechanic before the work commenced.

The skid worker should not have mounted the hauler wearing spiked boots, nor should he have walked across the engine bay to throw the cylinder from the hauler as there was no fall restraint system in place. A nearby log loader could have been used to sling the cylinder of the hauler to the ground.
