Safety Alert

Stabiliser ram failure & tower collapse - Madill 172

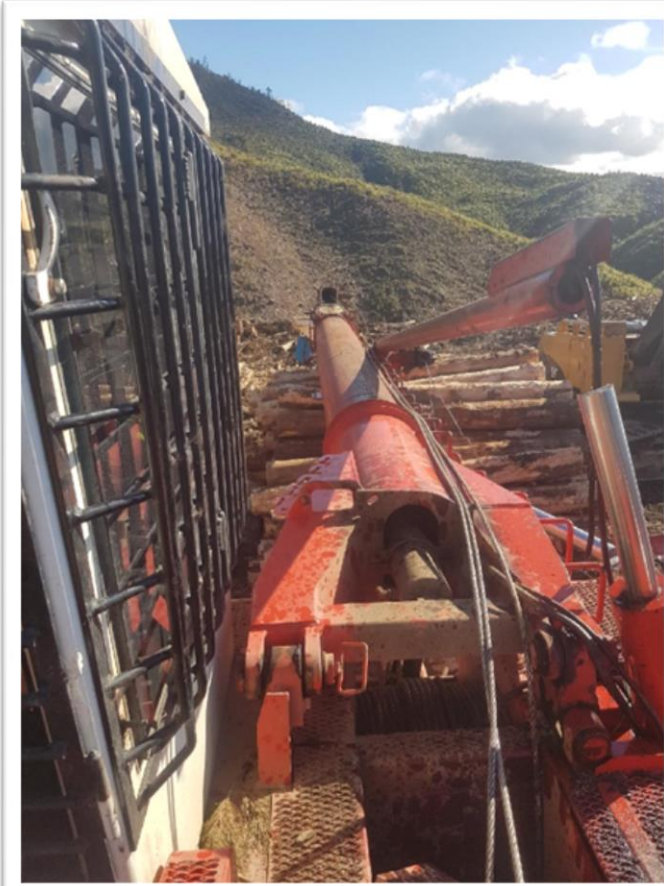
Photo 1: Tower rearward collapse

While repositioning the hauler, the stabilizer ram failed resulting in the pole collapsing backwards.

The hauler driver was about to push the lever that would place the tower in its correct pulling position, when he saw the Acme carriage moving toward the hauler. There was a bang and the tower fell to the ground behind the hauler.

- A snap guy (front guy rope) was not in use as a safety precaution. The snap guy would not have prevented the stabilizer rams from failing, but would have reduced the risk of the tower falling.
- The tower should be in the travel position or at least lowered to 50 foot to move and rig. This greatly increases stability and reduces the chance of failure due (as per manufacturer's recommendations)
- A safety strop (chain) could have been fitted on the stabilizer ram. While a strop would not have prevented the ram failing, it would have prevented the tower falling over when the ram failed.

- It is not recommended that the hauler is moved whilst the tower is at 70 foot. This could create a pendulum effect and make the hauler unstable. This will create extra weight and stress on the stabilizer ram and other parts of the tower. Follow the manufacturer's recommendations for shifting machine.

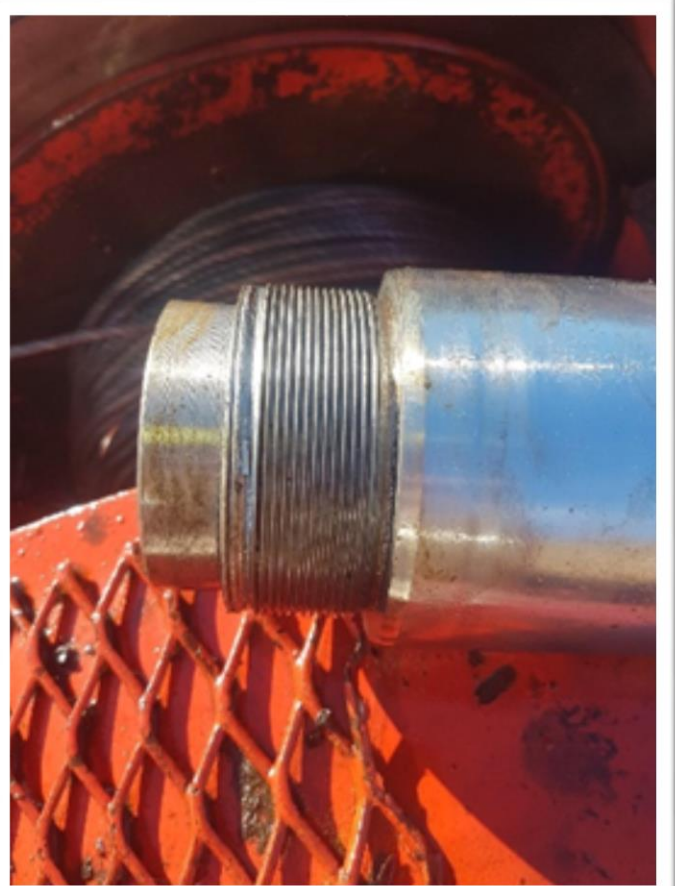
Photo 2: Thread separation on stabiliser ram

- Failure of the stabilizer ram - there was a failure with the connection of the piston to the ram. The piston is normally done up very tight and held in place by a grub screw and sometimes Loctite (or similar). In this case the stabilizer ram didn't have grub screws installed. This allowed the stabilizer ram to pull apart after the piston unscrewed from the end of the ram. The grub screws are not visible so without taking the ram apart there would be no way to know they were installed. Standard annual tower inspections would not pick this up.

- Mark and monitor the length of exposed hydraulic ram to confirm separation is not occurring.
- Ensure that only competent and qualified experts perform maintenance / repair work on machinery, especially safety critical components.

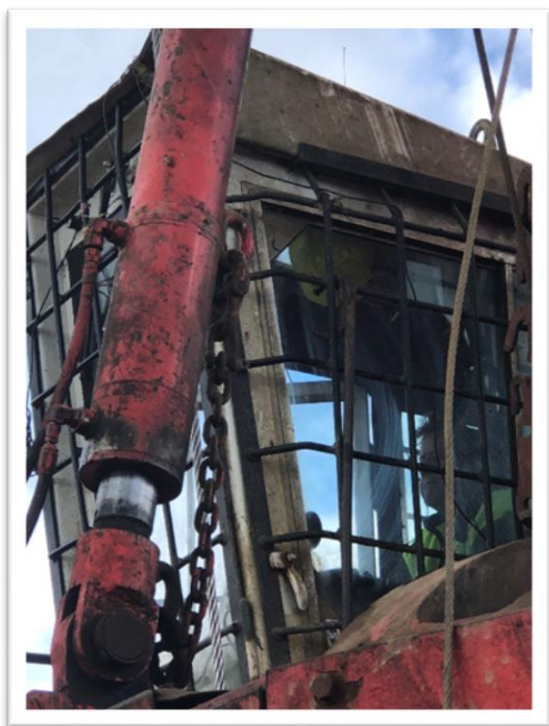
Photo 3: Safety Strop (chain) example

- Install a suitable strength safety strop (chain) on the stabiliser ram. This will help prevent the tower from falling over in the event of stabiliser ram failure.

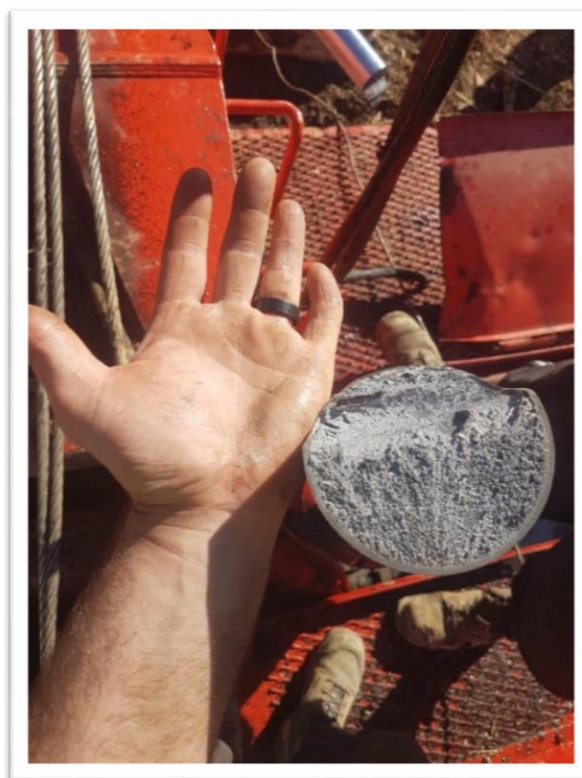
Photo 4: Severed lifting ram (consequence of stabilizer ram separation and tower collapse)
