Pan Pac Forests Safety Alert #10

Date: 27 July 2023	Focus Group: Cartage
Topic: Driving & Speed	Issued By: Health & Safety - Andrea

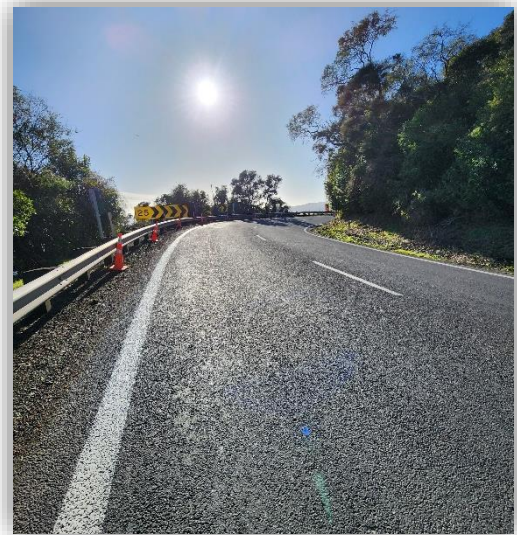
5th July 2023 a Log truck travelling north on State Highway 1 has entered a hairpin bend at Bulli Point. The hairpin bend was sign posted for 25km and truck entry speed was in excess of 40km/h, at the mid-point of the hairpin the truck speed was registered at 39km/h.

The trailer wheels have tracked off the road into the berm pulling the truck over the side barriers and down a bank.

A tree located several meters down the bank has taken the impact of the fully loaded unit and held, this alone stopped the truck from rolling into Lake Taupo.

- Speed was a significant causative factor in the incident.

- **Slow Down** - maintain your vehicle speed within the posted legal road limits.
- **10km/h under** - industry recommendation for log truck corner entry is the truck should be 10km under the posted speed limit.
- **Drive to the conditions.**
- **Seat Belts** – wearing seatbelts saves lives and significant injuries.
- **Log Book** – all rest breaks including the 10hr minimum shift break must be taken as per your licensing standards.
