Mechanical Failure on Hauler Spar

Investigation undertaken and Report Prepared by Brady Clements on behalf of Robbins Contracting Ltd

Incident Details

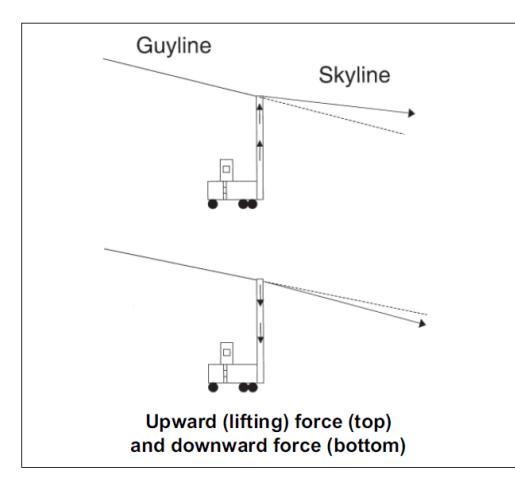
Image 1: This image is taken from the *Cable Logging Best Practice Guide for Forest Harvesting* it states that the recommended angle where the guy line attaches to the dead man is recommended to be less than 45°

Guyline angles should be as flat as possible to avoid extreme tensions. An angle of less than 45° is recommended. However, this may not always be possible. In this situation, the **Approved Code of Practice for Safety and Health in Forest Operations** states that an addition guyline shall be installed to appose the haul line.
