# SAFETY ALERT

## Yarder Stabilising Ram Failure Incident

### Thunderbird TY50/70 Towers – Rope Retrieval

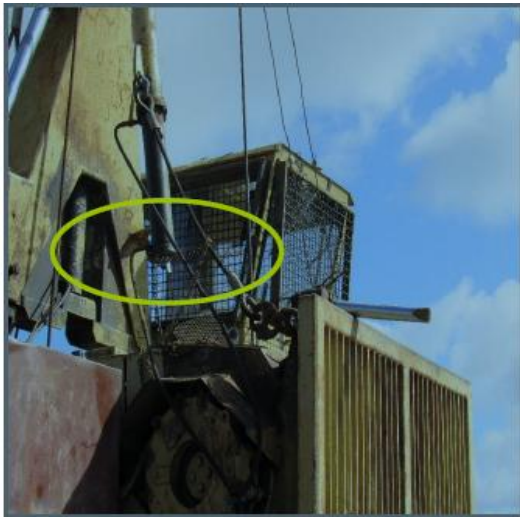
- The investigation revealed that the incident was the result of a stabilising ram failure.
- It identified that the Thunderbird manual prescribes the slackening of all guylines before rope recovery, therefore the tower was not supported by guylines when the stabilising ram failed.
- Also, the stabilising ram spear had been replaced with induction-hardened steel rather than the original mild steel design. Induction hardened steel provides excellent wear resistance and strength but does not have the same ductile microstructure of mild steel, which allows it to deform (bend or stretch) significantly under stress before fracturing, it absorbs energy well.

Figure 2. Close up of the hauler showing snapped spear

- 1. GUYLINE SAFETY:** While Thunderbird manuals allow slackening all guylines and locking the pole before rope recovery, it is recommended to keep at least one rear guyline in place to prevent tower collapse if the stabiliser ram fails.
- 2. STABILISING RAM SPEAR:** Owners must verify the steel grade of stabiliser ram spears. It is recommended that a replacement spear should be consistent with the original mild steel composition with good energy absorbing ductile properties.
- 3. LAGGED DRUMS:** Rope fleeing exposes workers for 15–20 minutes. Lagging drums reduces this risk. Owners should consider replacing at least the front drum when machines undergo major servicing.
- 4. ANNUAL INSPECTIONS:** Towers must be inspected annually by CBIP-certified inspectors. Inspectors should be briefed on the Kohurau incident and the importance of spear verification and ram integrity.
