Rayonier			<b>Workplace Notification</b>			
Forests		Safety Alert	Health Alert	Best Practice Advice		
Notification Number	17		Innovation Advice	Environmental Alert	Environmental Focus

Date: 4 <sup>th</sup> September 2024	Focus Group: Mobile plant R&M
Region: All	<b>Topic:</b> Safe inspection where entrapment hazards exist

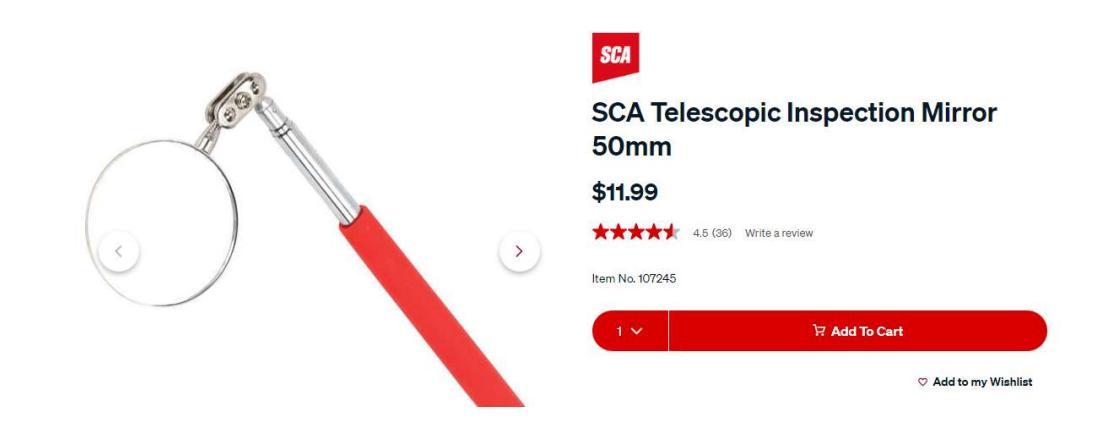
- Telescopic inspection mirrors or commonly known as a mechanics mirror was first created during the Great Depression in 1935. They went on to play a pivotal role in assembly plants worldwide during the Second World War. Today they are commonplace in workshops and fabrication plants worldwide.
- They are cheap and provide an effective means of gaining vision in hard to reach places while remaining at a safe distance.
- We recommend that this tool should be available in everyone's toolbox when performing repair and maintenance on our forestry sites.
- Once a fault is identified, the RMF SSoW guidance along with any manufacturer or supplier guidance and precautions MUST be followed to safely perform the work. Your risk assessment and controls will further support this process.
