# PF Olsen Toolbox Safety Alert 65

<b>Date:</b> September 2023	<b>Focus Group:</b> Log Transport
<b>Topic:</b> Drawbar Springs	<b>Issued by:</b> Mike Spiers, Nic Steens

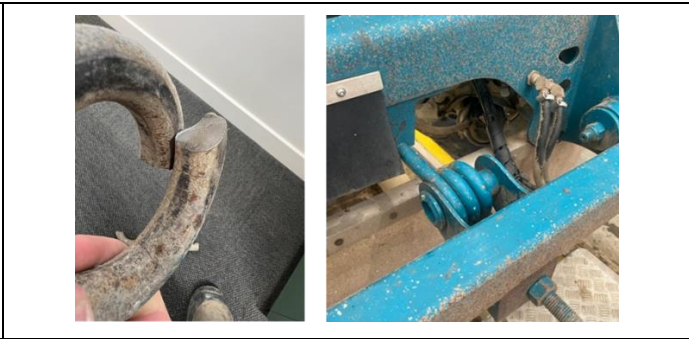
**Background and Incident:** Working together a truck driver and loader operator connected the trailer to the truck. While the driver went to set the bolsters the loader operator lifted the front of the trailer dolly to reposition the trailer. This repositioning placed strain on the pigtail drawbar spring (used to hold the drawbar up off the ground), which snapped, and sent parts of it as a projectile hitting the driver’s safety helmet.

- Keep the trailer as low to the ground as possible during repositioning, prior to loading. Lifting a trailer too high, at a steep angle, increases strain on the spring.
- Drivers must retreat to a safe zone during repositioning e.g., forward of the cab guard but definitely away from the line of fire.
- Conduct regular maintenance checks of the drawbar springs (for wear and stress fractures). The LTSC is currently looking into ‘lifespan’ recommendations.
